Manhole Inspection Summary

Manhole # S33Q__015MH

Insp Date: **2/5/08 10:05 AM**

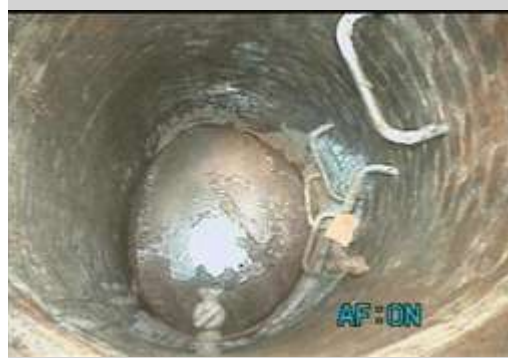
Defect 2

Count: **5** Missing: **0** ☒ **Corroded**

☒ **Evidence Of Surcharge** Depth: **1** (ft.) ☒ **Active Surcharge Present**

Corroded Steps & Surge Active

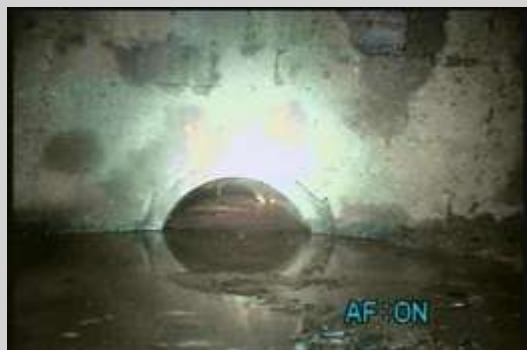
12 O'Clock Outflow

8 in. Circular Gravity Sewer
Pipe Out @ 12 O'Clock

Deposits: ☐ None ☒ **Mud** ☒ **Gravy** ☐ Debris ☐ Grease

Silt Depth: **4** (in.) Deposits Extent: **Heavy**
